ITA - AITES General Assembly and
World Tunnel Congress

Excavation of connecting tunnels in Centrum Nauki Kopernik underground train station on line II in Warsaw

M.A. Piangatelli, A. Bellone & M. Bringiotti
CIPA S.P.A., Rome, Italy

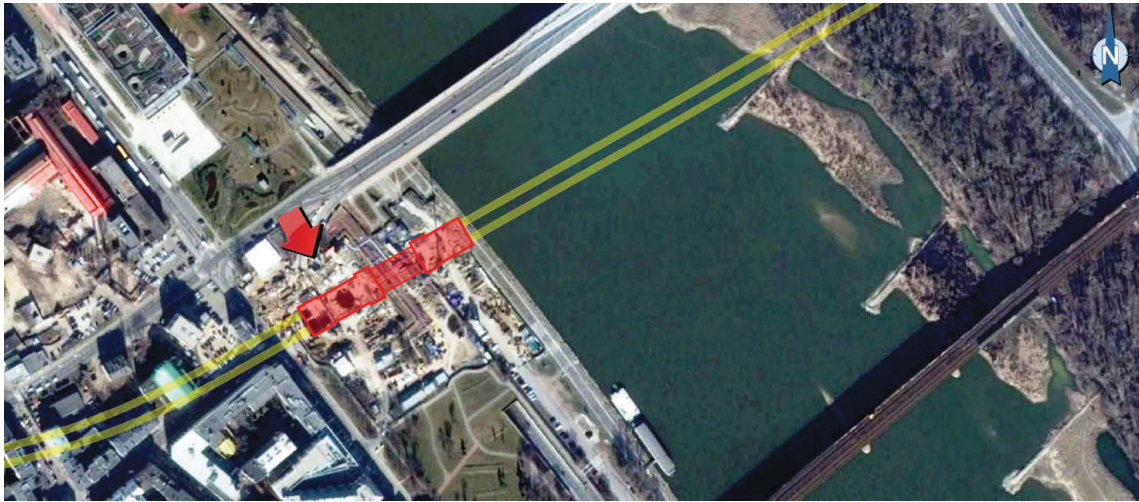
Figure 1. The Centrum Nauki Kopernik station and the Vistula river.

The Centrum Nauki Kopernik station on Line II of the Warsaw Underground is located alongside the Vistula river (Figure 1). This station hereinafter is referred to as station C13.

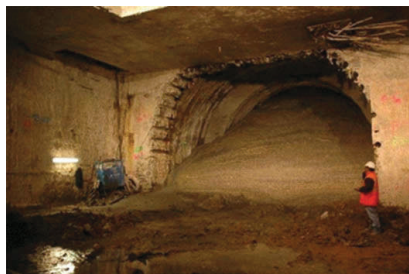
Figure 7. The collapse of the tunnel face.

At 10:45 PM, a foreman saw that something strange was happening. Some water was inflowing from the top and from the face of the tunnel. He immediately sounded the alarm, and a team of workers ran down into the station, at the tunnel face. At 11:00 PM they began to spray another layer of shotcrete on the face of the tunnel, but because the sprayed shotcrete was swelling and cracking in some areas on the face, the action taken was interrupted and all the workers attempted to place material against the face to contain it (Figure 7).

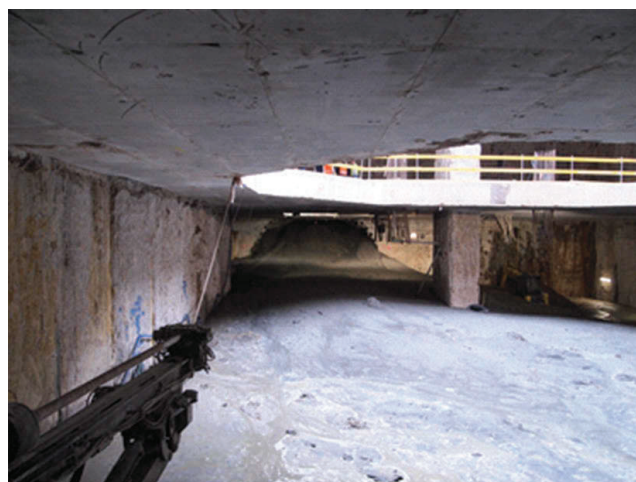
Figure 8. Water, sand and clay inflow from the tunnel.

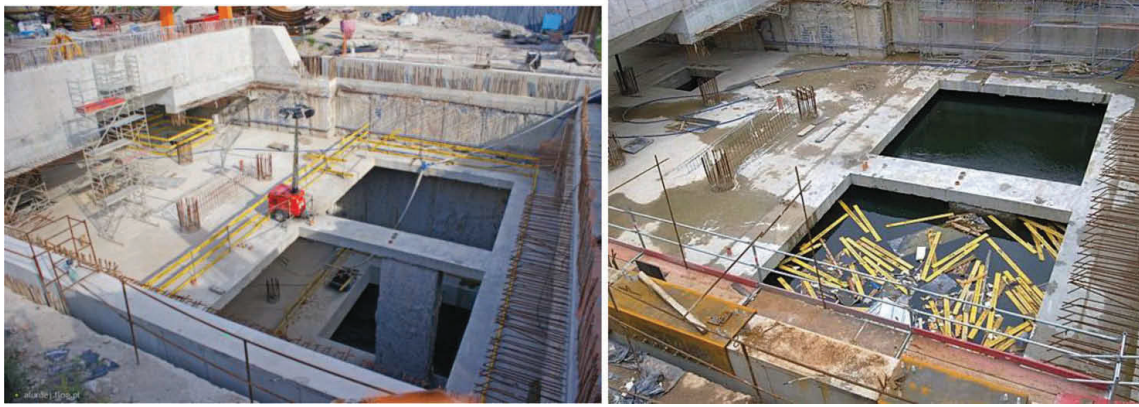
Figure 9. The station before the event and after the intentional flooding.

To avoid the feared collapse of the west side of the station, the flooding in progress was intentionally accelerated by pumping water from the Vistula river in order to balance the external pressure of the soil on the walls (Figure 9). Access to the WS tunnel was forbidden for safety reasons.

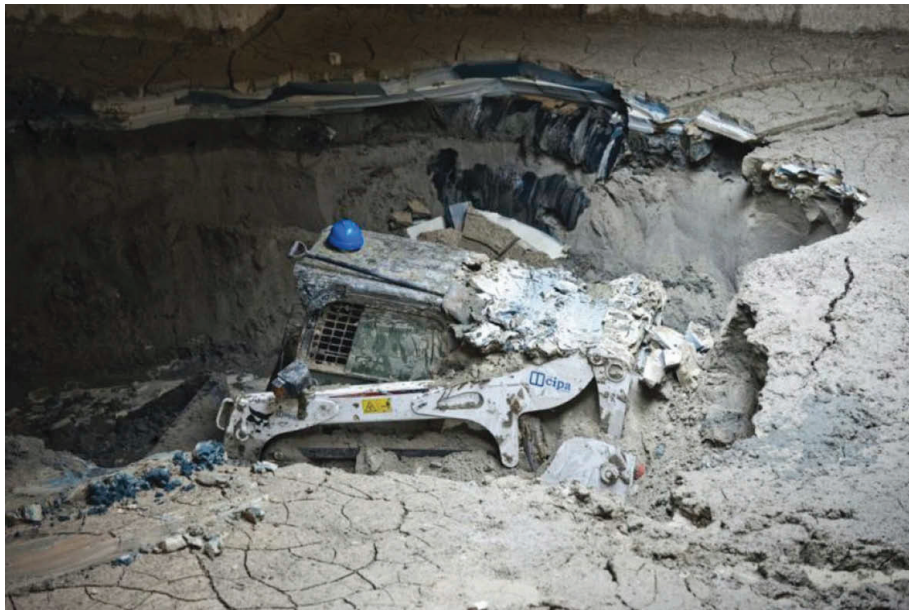
Figure 10. One of the buried machines.

Many machines were lost in the station (Figure 10). Fortunately, no one was injured.

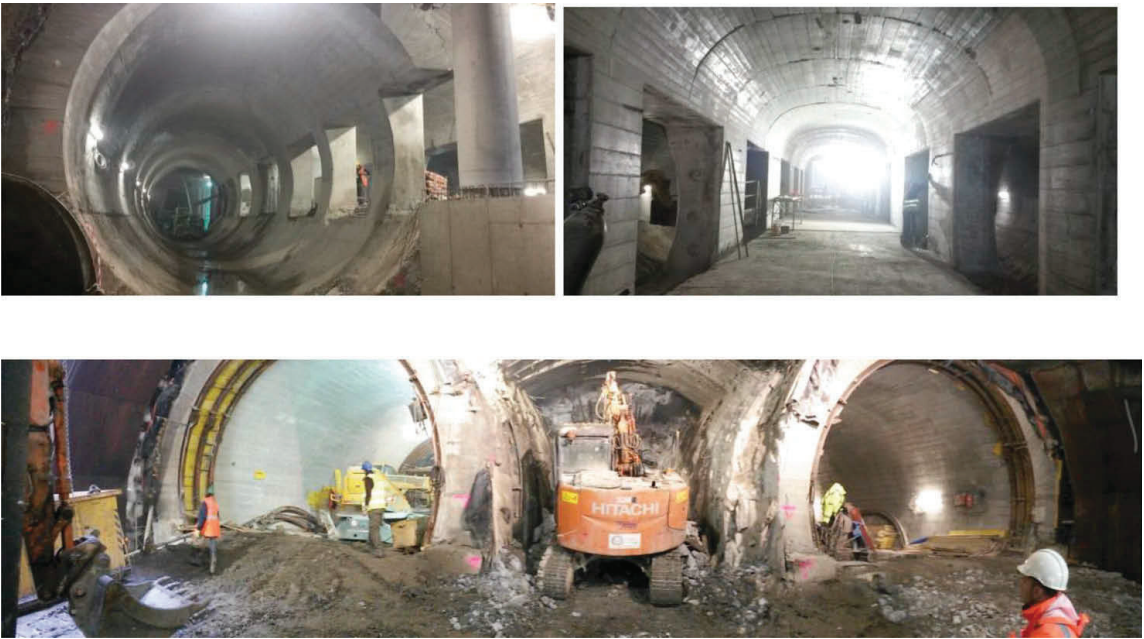
Figure 15. At top, a side tunnel; at centre, the central tunnel; at bottom, a panoramic photo of the three tunnels.

It took more than two and a half years to complete the tunnels, but, thanks to the efforts of the people who worked to solve the serious issues of this work in order to safeguard people, structures and equipment as far as possible, the tunnels were finished. Figure 15 and Figure 16 show some pictures of the tunnels during the works and how it appears today.

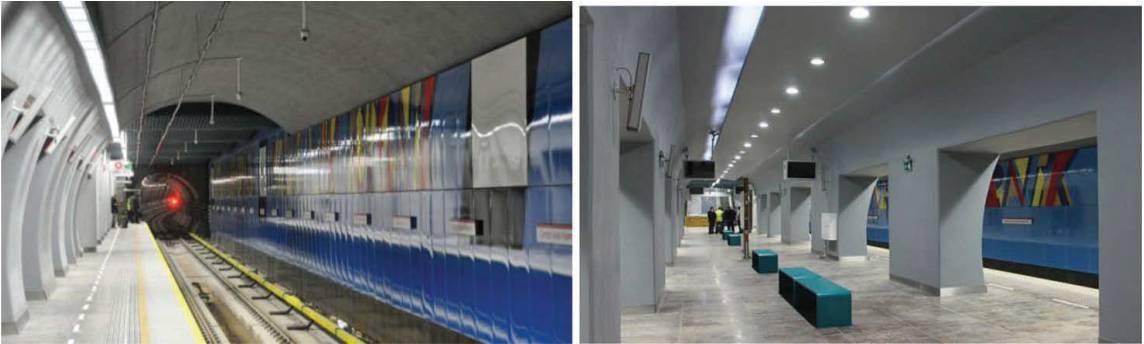
Figure 16. At left, a side tunnel; at centre, at right, the central tunnel.
